# STM8S003/103/903 Errata sheet

## STM8S003xx, STM8S103xx and STM8S903xx device limitations

This errata sheet applies to the STMicroelectronics STM8S003xx, STM8S103xx and STM8S903xx devices.

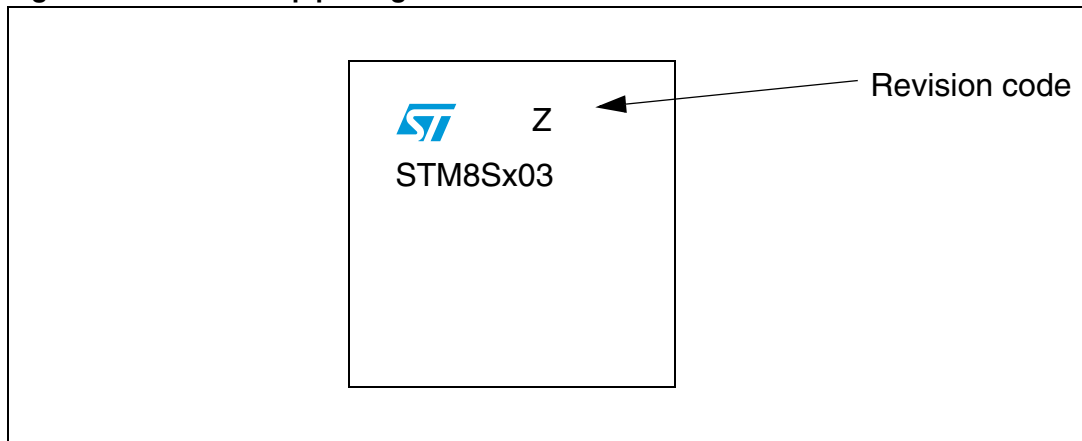
**Figure 1. LQFP32 top package view**

*Figure 1* shows the marking for the LQFP32 package.

1. Refer to [Appendix A: Revision code on device marking](#) for details on how to identify the revision code according to the packages.
